Post Quench Behavior of a Metallic Cladding (MC) No-Insulation (NI) Coil

Kim, K., Hu, X., Kim, K., Bhattarai, K.R., Radcliff, K. and Hahn, S. (ASC, NHMFL)

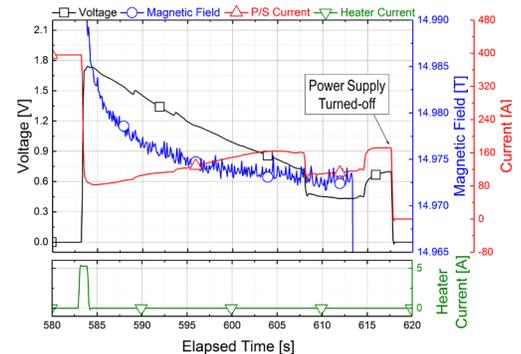
A metallic cladding (MC) no-insulation (NI) REBCO coil was constructed and tested. A key idea of the MC technique is to substantially reduce the charging delay of a conventional NI coil. The results confirmed that the use of MC tape may be an alternative way to reduce the charging delay of conventional NI magnets without sacrificing the self-protecting feature at a coil current density (J_e) up to 820 A/mm²[1]. However, during a long-term quench recovery test, a 15 T background magnet was quenched 30 s after the MC coil's quench at 820 A/mm² (Fig.1). We report details of the MC coil test results and our post-mortem analysis on the MC coil.

Fig.1 Quench of an LTS background magnet.

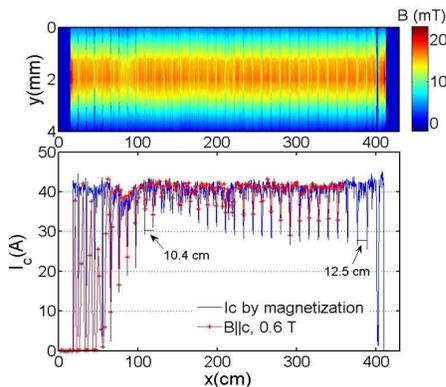
Fig. 2 shows lengthwise I_c test results using the YateStar ($B_{||c}$ of 0.6 T), where a periodic damage pattern was observed: a 10.4 cm damage period was found in the inner pancake section and 12.5 cm in the outer section. These periodicities agree well with the perimeter of each section. The results imply that the damage was “localized” and propagated in the radial direction. After the YateStar test, a visual inspection was performed on the tapes and localized “spot” damages were visually identified near the innermost turns (Fig. 3). Note that the first ~4 cm of the 1st turn is attached to the current lead and was cut-off prior to YateStar measurement in Fig. 2. The peel-off of the stainless steel layer was observed at the rear of the damaged turns as seen in Fig. 3, where bottom and top pictures correspond to the respective front and rear side of the tape.

Fig.2 YateStar results of the damaged MC tape after the background magnet quenched.

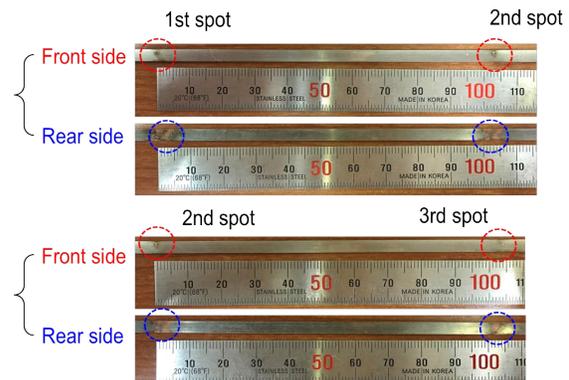
Fig.3 Pictures of the damaged spots and peel-off of stainless steel layers.

The MC coil survived after multiple quench tests at its average coil current density up to 820 A/mm², which implies a strong potential of the MC technique to mitigate the charging delay of an NI coil without sacrificing the self-protecting feature. Yet, localized damage of the MC coil was observed after an unexpected LTS background magnet quench. From our post-mortem analysis with YateStar, a periodic damage pattern was observed that we interpret to indicate radial propagation of the damage. We understand that peeling of the stainless steel cladding layer may be a primary reason for the damage, as a large induced current may have been concentrated in such local spots, which ultimately leads to excessive heat generation. More studies, experimental and analytic, are in progress to better understand the quench behavior of MC coils.
