# **Evidence that filament fracture occurs in an ITER toroidal field conductor after cyclic Lorentz force loading in SULTAN**

We analyzed the ITER TFEU5 cable-in-conduit conductor (CICC) after the full SULTAN conductor qualification test in order to explore whether Lorentz force induced strand movement inside the CICC produces any fracture of the brittle Nb<sub>3</sub>Sn filaments. Metallographic image analysis was used to quantify the change in void fraction of each sub-cable (petal); strands move in the direction of the Lorentz force, increasing the void space on the low force side of the CICC and producing a densification on the high force side. Adjacent strand counting shows that local increases in void space result in lower local strand-strand support. Extensive metallographic sampling unambiguously confirms that Nb<sub>3</sub>Sn filament fracture occurred in the TFEU5 CICC, but the filament fracture was highly localized to strand sections with high local curvature (likely produced during cabling, where strands are pivoted around each other). More than 95% of the straighter strand sections were free of filament cracks, while less than 60% of the bent strand sections were crac

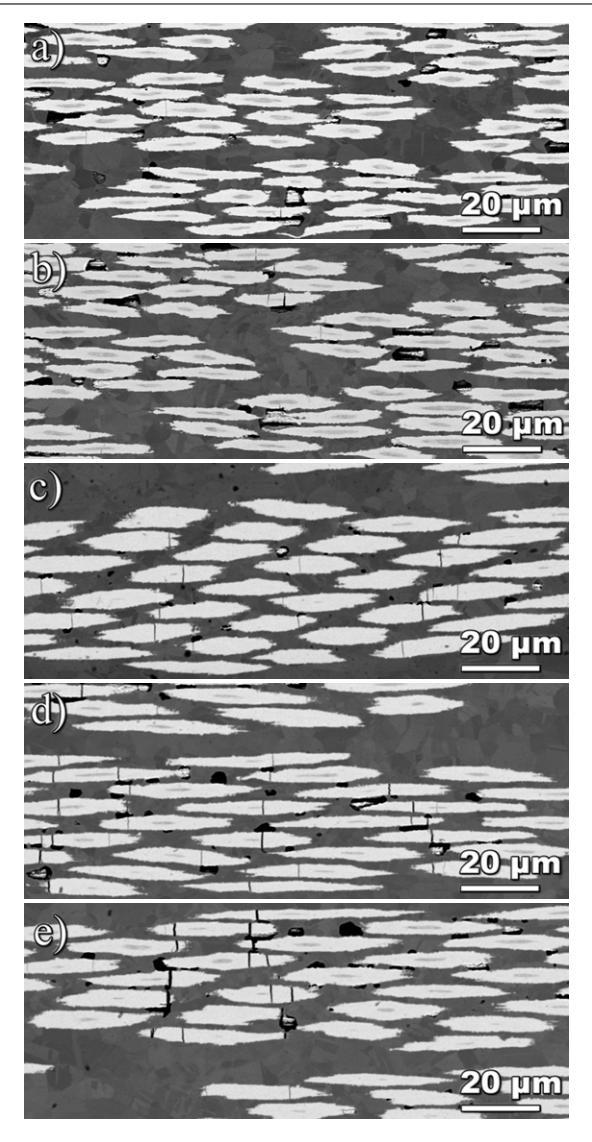
crack density range and its equivalent number of cracks per mm of Nb<sub>3</sub>Sn filament obtained by multiplying the crack density per unit area by the length of filament exposed in the given area. For the strands analyzed here there is about 170 mm of filament exposed per mm<sup>2</sup>. Figure 8 shows images corresponding to these different crack density levels.

**Figure 8.** Crack density levels (a) level 1 (b) level 2 (c) level 3 (d) level 4 (e) level 5.

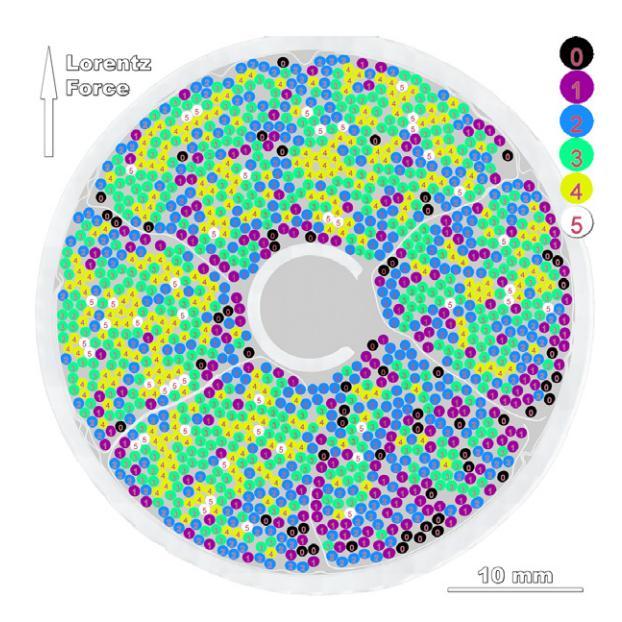
**Figure 10.** Transverse high field zone cross-section with the strands shaded according to the adjacent strand count (i.e. number of nearest-neighbor strands), which ranges from 0 to 5 (most densely packed).

of a particular filament. The cross-section in figure 10 corresponds to the high field cross-section in figure 9. The predominance of dark shaded filaments in the lower right hand petal (petal 3), shows that the strands have moved away from each other increasing the void fraction significantly and implying a reduction in strand-to-strand mechanical support. Conversely the adjacent low force petal (petal 4) remains densely packed.

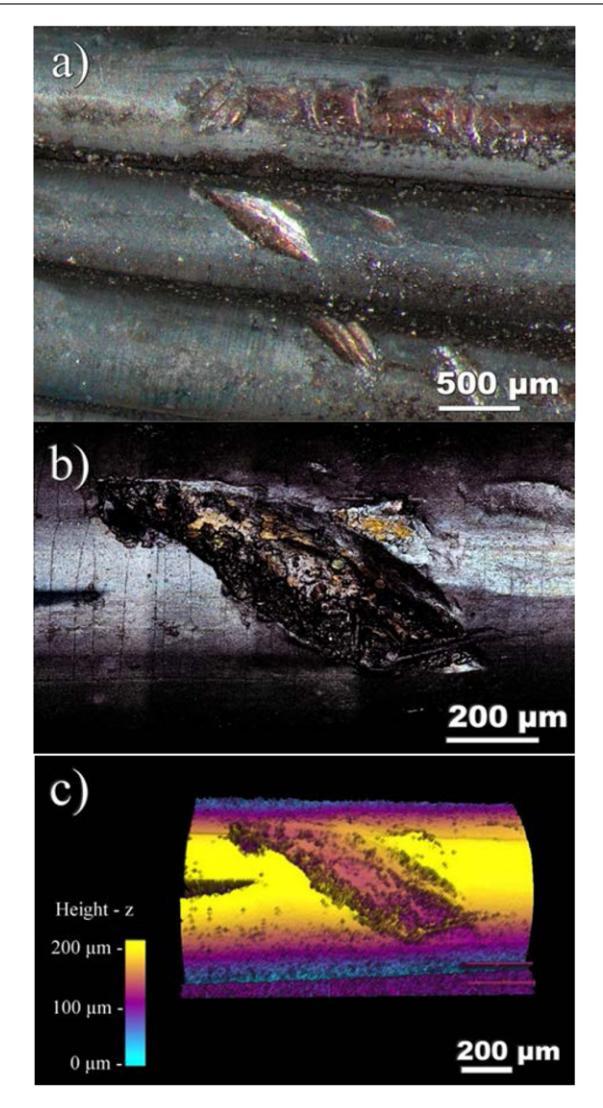
**Figure 11.** (a) The edges of the sub-cable wrap often left behind indents like this one. (b) a LSCM image of the indented area. (c) A 3D image of the indented area.

Some deeply indented strands of the type shown in figure 4 were imaged using the laser scanning confocal microscope (LSCM) to measure the scratch depth. Figure 11 shows one of the worst cases, an indentation 63  $\mu$ m deep, almost halfway through the copper annulus.

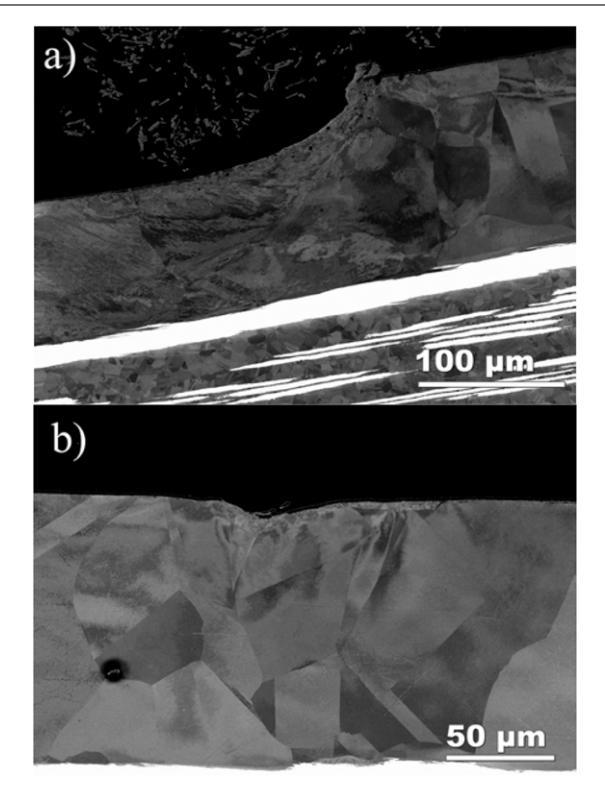
We have also taken several electron backscatter FESEM images to reveal the copper grain structure around the damaged area of the strands. Figure 12 shows two micrographs of TFEU5 strands with surface damage, while figure 13 shows the pinched surface of a crossing TARSIS strand [19]. The Cu grain structures for all these images show heavily cold worked copper grains around the damaged area, an indication of damage that has occurred after cabling, jacketing, and SULTAN sample preparation because the final Nb<sub>3</sub>Sn reaction heat treatment is much more than is required to fully anneal the Cu stabilizer; thus the damage occurred either under cool down or under cyclic loading. It is clear that

**Figure 12.** TFEU5 scratched strands. There is clear evidence of cold work under the scratch indicating that it occurred AFTER reaction under the cooling, warming or electromagnetic loading in SULTAN.

Concerning the second question as to when observable damage to the strand surface of the sort depicted in figures 11-13 occurs, there seems to be a clear answer. Figure 12 shows unambiguous evidence of elongated Cu grains under the indent. Since Cu anneals only on being heated above about 450-500 °C and the reaction heat treatment of the wire includes steps of 575 and 650 °C each for 100 h, it is quite clear that cold work done before reaction would have been removed during reaction. Thus we can conclude that the indentation occurred after cabling and after reaction and that either thermal strain during cooling to low temperatures or the Lorentz force loading itself must be implicated in this damage. However, it also appears that this damage is restricted to the Cu annulus around the diffusion barrier and that it did not cause any filament damage. Thus the net impact of this surface deformation due to sub-cable wrap, though not very pretty, is without functional impact on the conductor. This conclusion is also consistent with similar postmortems on flow under crossing strands tests in TARSIS, as shown in figure 12.

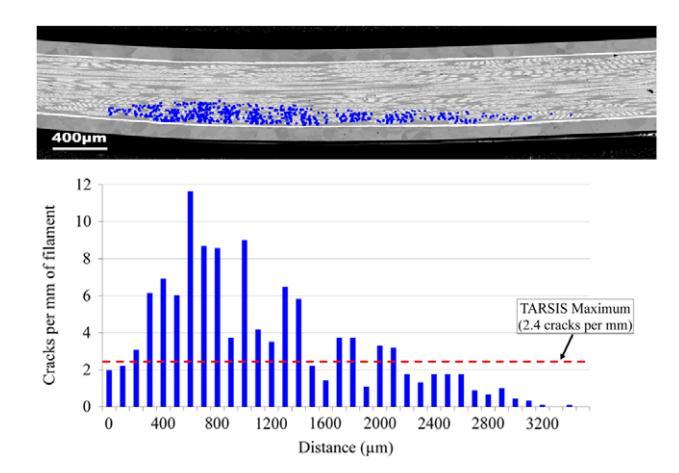
**Figure 14.** Level 5 cracks found in a HFZ strand along the strand length. The histogram displays the crack concentration (per 100  $\mu$ m width band: figure 7) variation along the length of the analysis region. For reference, the dotted line represents the maximum crack concentration that we have observed in TARSIS-tested strands.

of the bent segments in the HFZ were crack free. Very high levels of filament damage were observed in some bent segments. Figure 14 shows a histogram of the very high, level 5 crack density observed in a curved segment extracted from petal 3 in the high field zone. It is clear that there is a local maximum crack density and a quasi-Gaussian decay away from the maximum that is localized to a length of about 3 mm. These cracks concentrate on the outer side of the bend, as was the case for every studied strand segment, regardless of crack density. The dotted line on the graph represents the significantly lower (level 3) maximum crack concentration that we analyzed for controlled TARSIS-tested strands from Twente-corresponding to 10 kN m<sup>-1</sup> loading (the heaviest loading the TARSIS samples supplied by Twente). The implication of finding localized cracks on the outer bend surface in figure 14 is that there has been an additional bend strain under SULTAN testing that has produced sufficient tensile strain on the outside of the bend that filament fracture becomes possible.

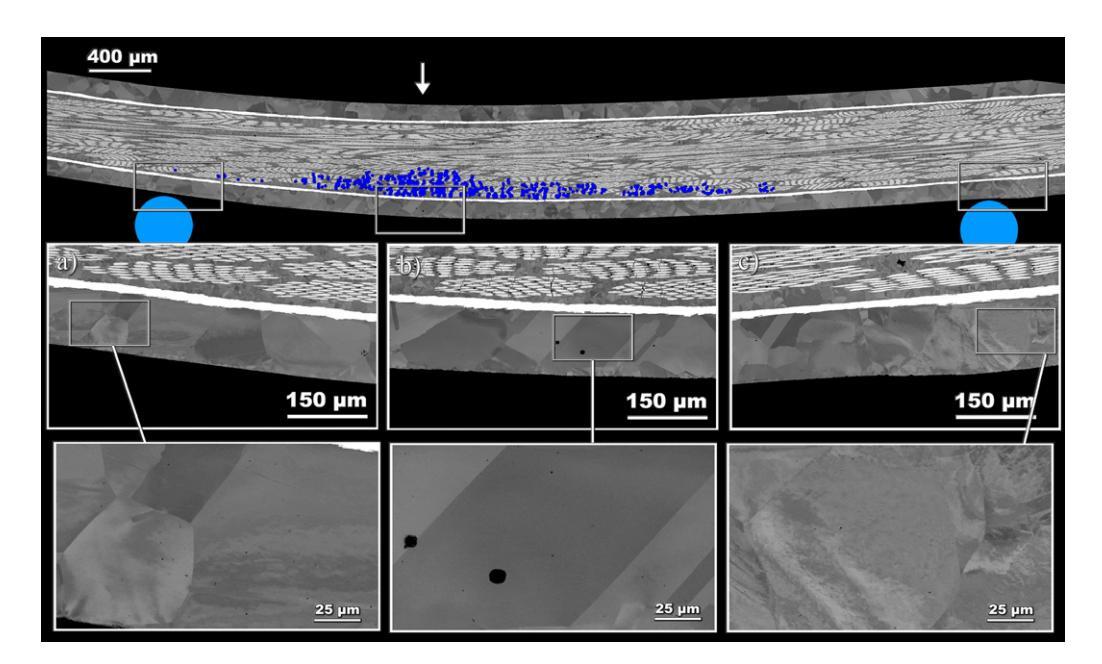
Figure 18. Level 5 cracks found in a HFZ strand along the strand length showing inserts of cold worked copper suggesting pivoting points. The red dots indicate where the neighboring strand was introducing two pivot points that induce this bending moment.

inset (b) with very well defined grain boundaries and strain free grains. Areas (a) and (c) are the exception. Here, the grain boundaries are less defined and show dislocations and irregularities similar to those seen in figure 13 suggesting cold worked copper. This is clear evidence of strand-to-strand contact points acting as pivot points that allow for additional bending. These contact points are represented by the blue dots on the image. In fact, inset (c) shows deformation caused by the neighboring strand.
