# **Evidence that filament fracture occurs in an ITER toroidal field conductor after cyclic Lorentz force loading in SULTAN**

We analyzed the ITER TFEU5 cable-in-conduit conductor (CICC) after the full SULTAN conductor qualification test in order to explore whether Lorentz force induced strand movement inside the CICC produces any fracture of the brittle Nb<sub>3</sub>Sn filaments. Metallographic image analysis was used to quantify the change in void fraction of each sub-cable (petal); strands move in the direction of the Lorentz force, increasing the void space on the low force side of the CICC and producing a densification on the high force side. Adjacent strand counting shows that local increases in void space result in lower local strand-strand support. Extensive metallographic sampling unambiguously confirms that Nb<sub>3</sub>Sn filament fracture occurred in the TFEU5 CICC, but the filament fracture was highly localized to strand sections with high local curvature (likely produced during cabling, where strands are pivoted around each other). More than 95% of the straighter strand sections were free of filament cracks, while less than 60% of the bent strand sections were crac

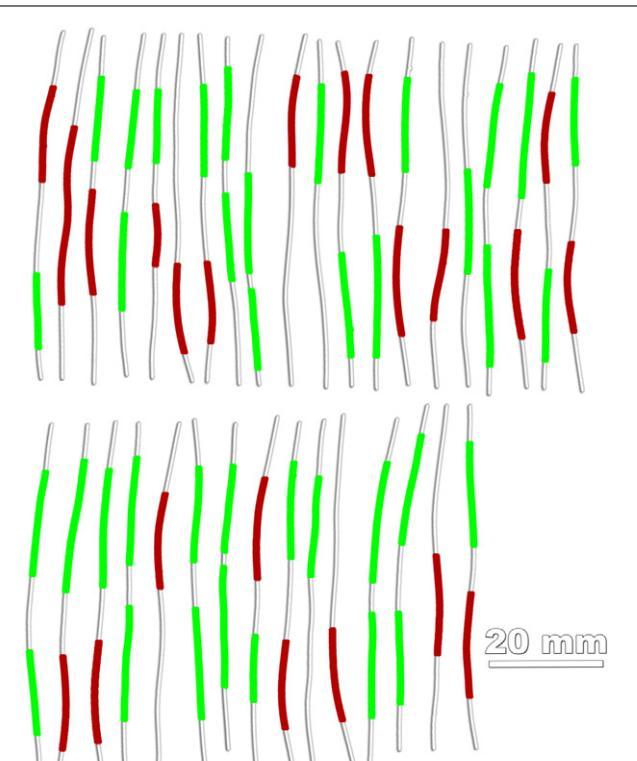
**Figure 6.** An annotated 2D scan of strands extracted from the HFZ petal 3 position c. Those segments highlighted in red/dark were classified as 'bent' and those highlighted in green/light as 'straight'.

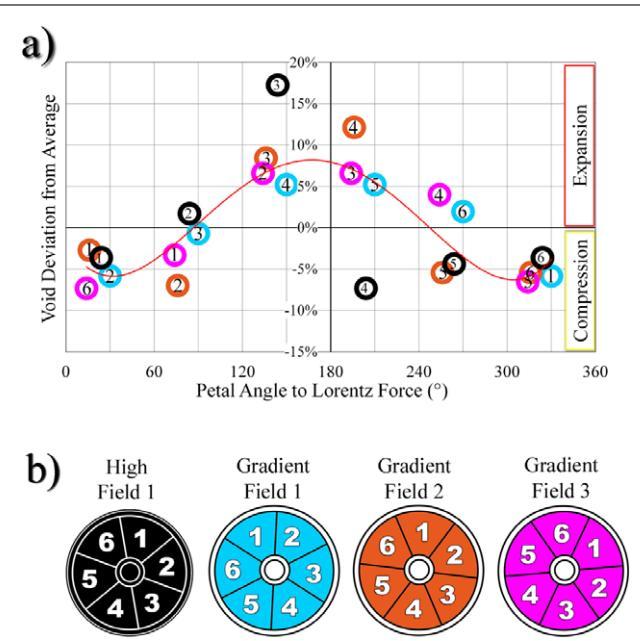
has undergone an expansion. Although there is some scatter, it is clear that there is a quasi-sinusoidal distribution of void fraction, which is about 10% denser on the high force side  $(0^{\circ} \text{ or } 360^{\circ})$  and correspondingly less dense on the low force side  $(180^{\circ})$ . Most of the scatter comes from petal 4 of the high field cross-section (black). This is proportional to the large expansion suffered by petal 3 (almost 17%) suggesting that the strand movement within the petal is not independent of adjacent petals.

**Figure 9.** (a) Petal void redistribution after EM cycling.  $0^{\circ}$  represents the high force side of the cable and  $180^{\circ}$  represents the low force side of the cable (b) color key.

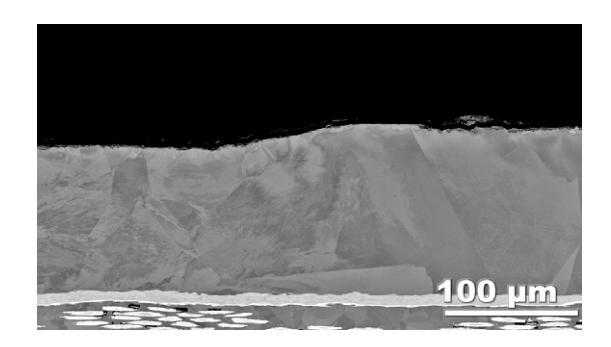
Figure 13. Pinched surface of a crossing TARSIS strand indented at  $10 \text{ kN m}^{-1}$  (strand sample courtesy of A Nijhuis of the University of Twente).

the damage observed in the TFEU5 strand is much greater than any produced in the TARSIS testing, perhaps reflecting the fact that TARSIS damage is induced by strand crossing and the TFEU5 damage by indentation of the stainless steel petal wrap into the soft (annealed) Cu annulus but also indicative of very high local forces in the conductor elements.

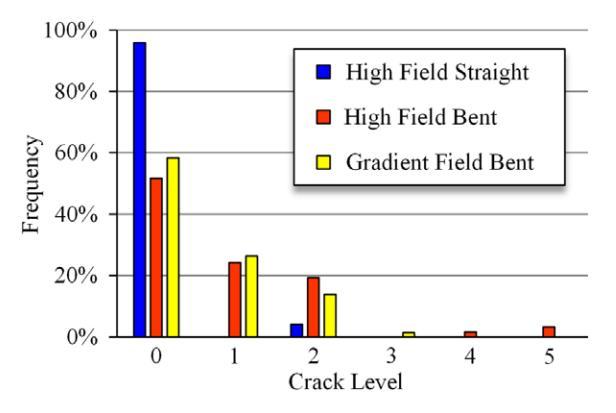
The percentages of damaged segments are represented graphically in figure 15 by crack concentration level. Notice that in the HFZ, the population of damaged segments contains crack density levels 1–5, while in the GFZ it varies only

Figure 15. Percentage of segments containing the specified crack density level within their respective group. Note that crack level zero means that cracks were not seen, meaning that most strands were not damaged.

from 1 to 3, suggesting that the drop in overall Lorentz force (the lowest GFZ background field is 23% less than HFZ background field) is sufficient to eliminate the worst levels of cyclic damage but does not eliminate filament cracking. These very high levels of filament fracture on the HFZ only could also be attributed to the softening of the cable's HFZ segment suspected by Mitchell *et al* [6].

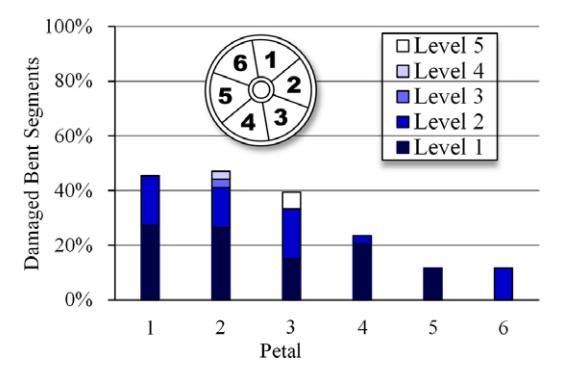
Figure 16 plots the distribution of damaged strands by petals. In this case there is the appearance of a trend from petal to petal in sequence from petal 1 to petal 6 but as both petals 1 and 6 are 'high force' there does not appear to be a direct relationship between crack density and the direction of the Lorentz force. Perhaps this is not surprising because as the strands become more densely packed on the high force side during testing, their ability to cyclically bend becomes more restricted, and conversely for the low force side where the strands become relatively less restricted and thus the amplitude of bending is likely to change in a complex manner over the duration of the test. Our analysis of crack locations indicates that localized pivot points with small radius of curvature have the greatest influence on crack density, rather than a simple global shifting of the strands inside a petal. The degradation produced at these local pivot points can be enhanced by stronger Lorentz forces acting on the HFZ, hence the high levels of filament fracture seen in the HFZ.

Figure 16. Percentage of all damaged bent segments from both HFZ and GFZ sorted by petal.

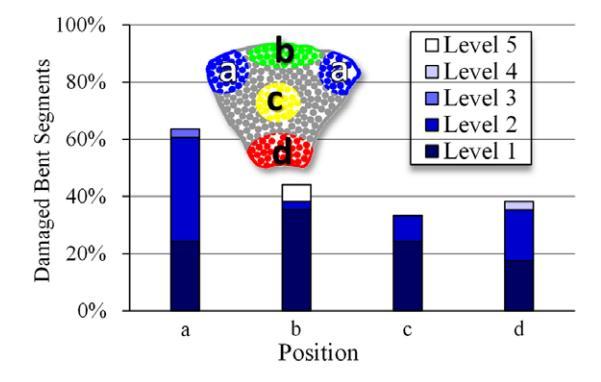
In figure 17 the crack concentrations for all segments are broken down by the four locations of interest within the sub-elements. The location of the highest crack concentration is position 'a' at the outer corners of the sub-element.

**Figure 17.** Percentage of damaged bent segments from both HFZ and GFZ and from all petals sorted by position. The population of damaged strands is higher for the petal corners.
