## Fabrication of the Coils for the 60 T Controlled Waveform Pulsed Magnet

Iain Dixon<sup>1</sup>, Todd Adkins<sup>1</sup>, Ke Han<sup>1</sup>, Rongmei Niu<sup>1</sup>, Doan Nguyen<sup>2</sup>

1. National High Magnetic Field Laboratory, FSU; 2. National High Magnetic Field Laboratory, Los Alamos National Laboratory

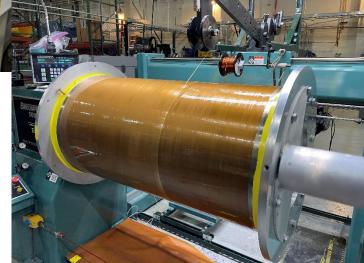
Figure left: View down the bore of coil 7 after epoxy impregnation at FSU. The epoxy impregnation is one of the many detailed procedural steps that includes conductor fabrication, quality control inspections, winding, joint and termination fabrication, outer shell fabrication, epoxy impregnation, Zylon reinforcement application and break out of the coil from the epoxy monolith after impregnation,

Figure right: Winding Zylon fiber with epoxy over the external shell at LANL is a process that further strengthens the pulsed coil against the huge magnetic forces that are generated in fractions of a second within the pulsed magnets. Zylon was implemented by the MagLab and is now one of the state-of-the-art reinforcement methods employed in the MagLab pulsed magnets.

Several design changes and quality improvements have been implemented in the rebuilt coils. To reduce the risk of shortened fatigue life, non-destructive evaluation using eddy currents was performed over every inch of the wire to detect inclusions or flaws. Damaged sections were either repaired or rejected. Thanks to the diligent efforts of the FSU materials team in strengthening the pulsed conductor supply chain, the conductor for coil 7 was changed from Al60 to CuCrZr, which offers improved strength and quality. An added benefit of CuCrZr is the availability of long continuous lengths, which eliminates the need for interlayer joints—a time-consuming process that introduces additional risks during coil production. The coils also feature an improved high-strength resin insulation system, which has already been successfully demonstrated in several large superconducting coils. Additionally, the reinforcement modulus has been increased by overwrapping the Nitronic shell with Zyon.
