“Test Coil Zero” on the Path to 40T

E. Bosque, H. Bai, M. Bird, A. Gavrilin, S. Gundlach, B. Jarvis, K. Kim, D. Kolb-Bond, S. Marshall, A. Voran, P. Xu,
National High Magnetic Field Laboratory

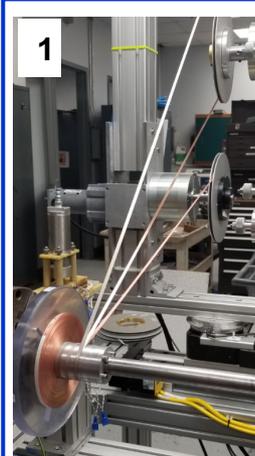
Fig 1: Reinforcement is co-wound between each pair of REBCO tapes.

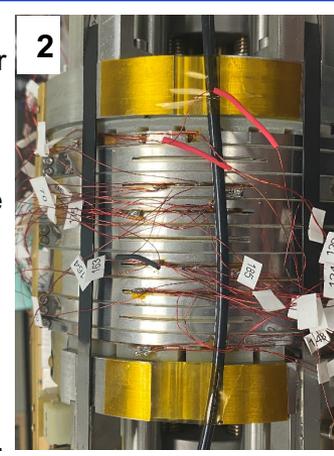
Fig 2: “Test Coil 0”, wound and instrumented just before being inserted into a 12T test bed magnet

Test Coil 0 consists of a stack of 8 double pancake modules that required new crossover, joint, and terminal technology able to withstand high strain operating conditions of a completed magnet. As the MagLab is a user facility and its users will sweep the future 40T magnet, magnet cycling lifespan is a crucial design criteria for the 40T magnet, unlike accelerator and NMR magnets that operate at a fixed field.

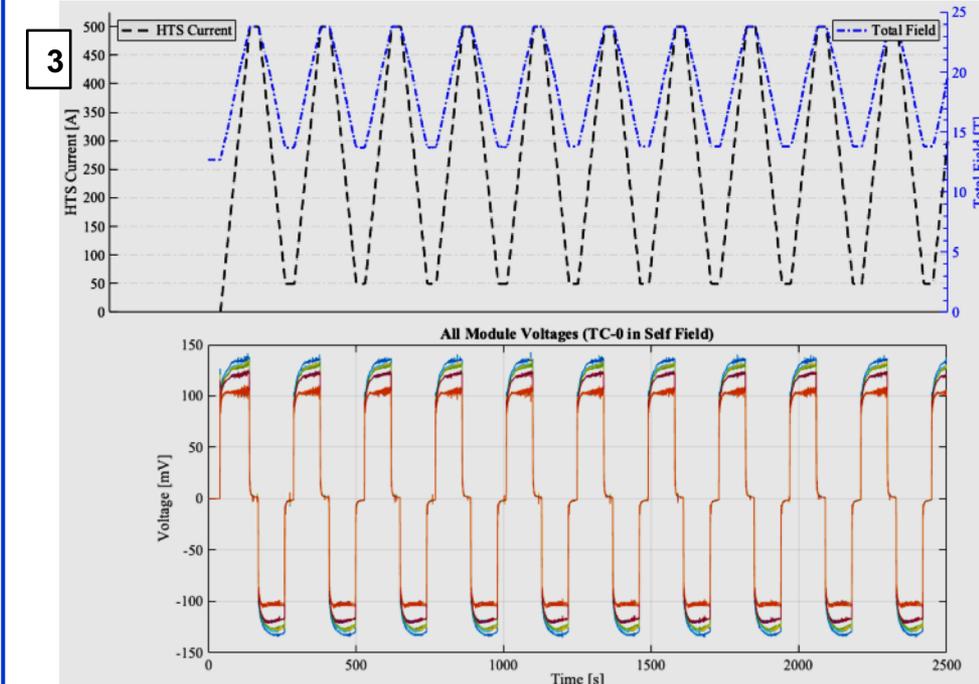
Fig 3: (top) A sampling of ten rapid (~250sec) fatigue cycles to 500A. Voltages (bottom) show a healthy coil.

Test Coil 0 was designed to put the conductor into high strain (>0.5%) over many cycles. Though other MagLab-built REBCO test coils have reached many thousands of cycles, those coils were significantly smaller, consisting of only 1.9m and 250m of conductor, respectively. Test Coil 0 was wound with over 1300m of conductor and was fatigue cycled 225 times with no signs of damage!

Test Coil 0 addressed many technical challenges. With an operating current of 500A (~250A in each tape), it nearly doubled the ratio of transport current to critical current, reaching 50%. (The 40T design targets a 70% critical current ratio.) In addition, all of the test coil components were proven to perform well up to a transport current of 550A.
